Los Angeles County
Department of Regional Planning

**SUBJECT: Project No. R2014-02411-(5)
Minor Conditional Use Permit No. 201400014, Oak Tree Permit No.
201400035, and Environmental Assessment No. 201400194
HO Meeting: April 19, 2016
Agenda Item: 5**

Land Design Consultants, Inc.

Re: Oak Tree Permit No. 201400035, APN: 5830-003-016 - Canyon Crest Road
LDC Project No. 13038-001

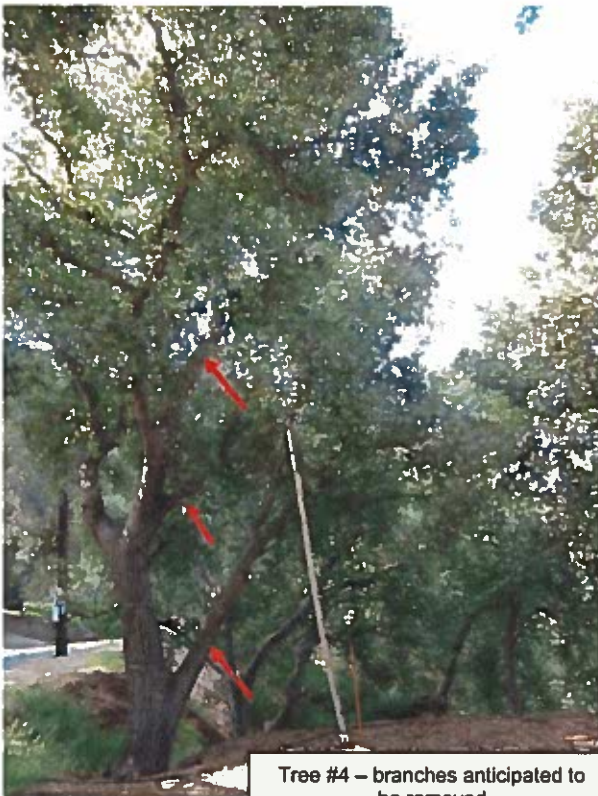
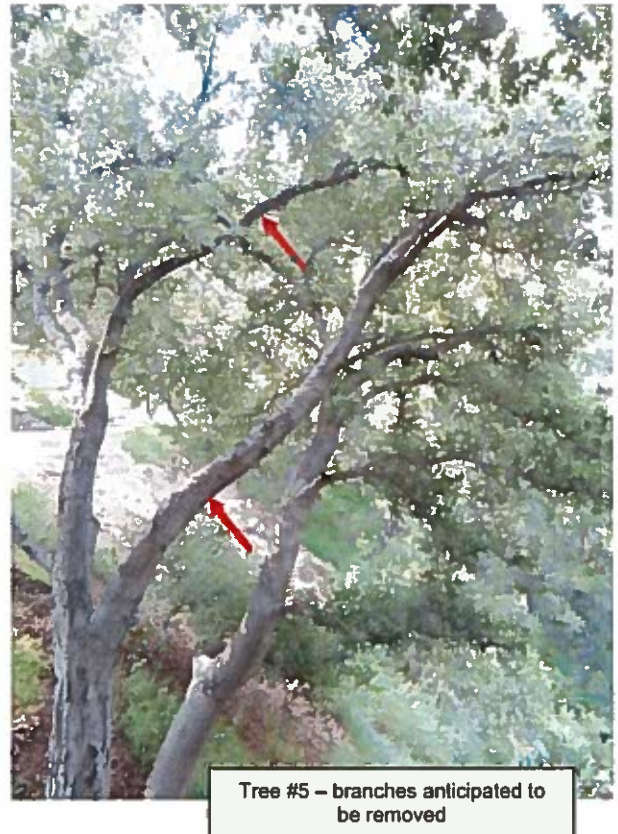
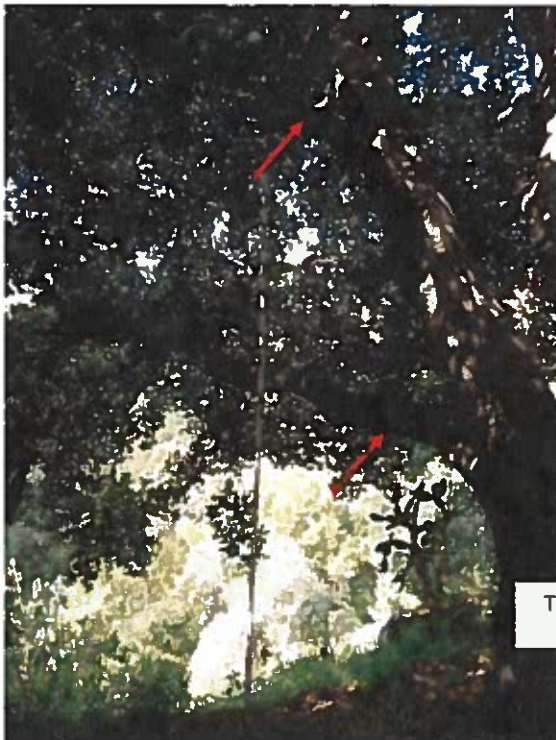
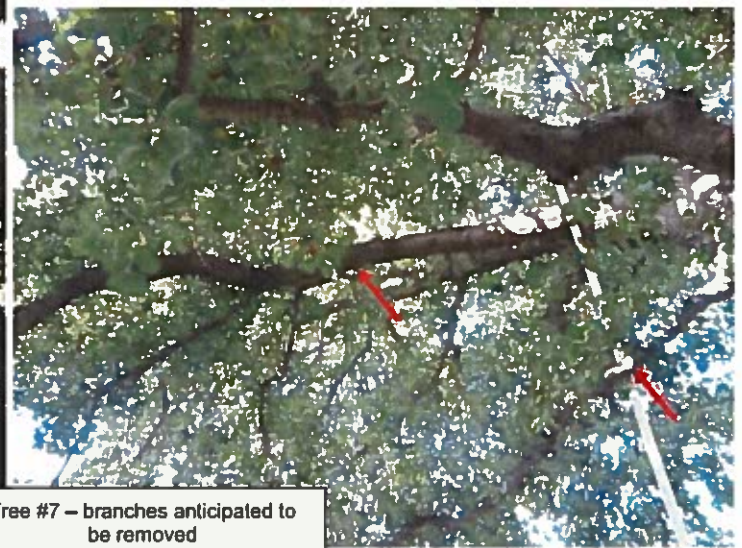
- f. The height of the structure is 31 feet, but the trees are much lower than 33 feet. How does the building fit into the slope under the trees? I believe that the applicant should be required to put up story poles to demonstrate the actual footprint of the structure and how it interfaces with the trees.

Response – Unsanctioned story poles were installed by an unknown (to me) party when I made my site visit on April 14, 2016. Although the poles are not exact, they give a clear indication of the extent of pruning that will be required for the placement of the building. Pruning to trees #4, 5, and 7 will be required to accommodate the placement of the building. Tree #4 will require the removal of the 9.5" trunk that leans west over the slope where the residence will be situated. In addition, a 6" scaffold, a 5" branch, and a 3" branch will be pruned from the western canopy. Overhanging canopy will still be present above these cuts and these cuts will not dramatically unbalance the canopy. Tree #5 will require the removal of an 8" scaffold and a 4" branch. The trunk leans south and its canopy faces a mostly southeast direction. The removal of these branches will not result in any additional unbalancing of the canopy. Tree #7 will require the removal of a 10" scaffold, 7" branch, 5" branch, and 2" branch. This tree exhibits a low branching structure and the removal of these branches will raise the canopy. Overhanging canopy will still be present above these cuts and these cut will not dramatically unbalance the canopy. Photos are included below to demonstrate those branches that will require removal.

In order to incorporate these trees into the project design, the above-described pruning is necessary. Though this amount of pruning may not be ideal, it will allow the trees to be preserved rather than removed. Pruning of the oaks will only take place during the dormant months from July through September.
